Technical Evaluation of the Gold King Mine Incident

San Juan County, Colorado

October 2015

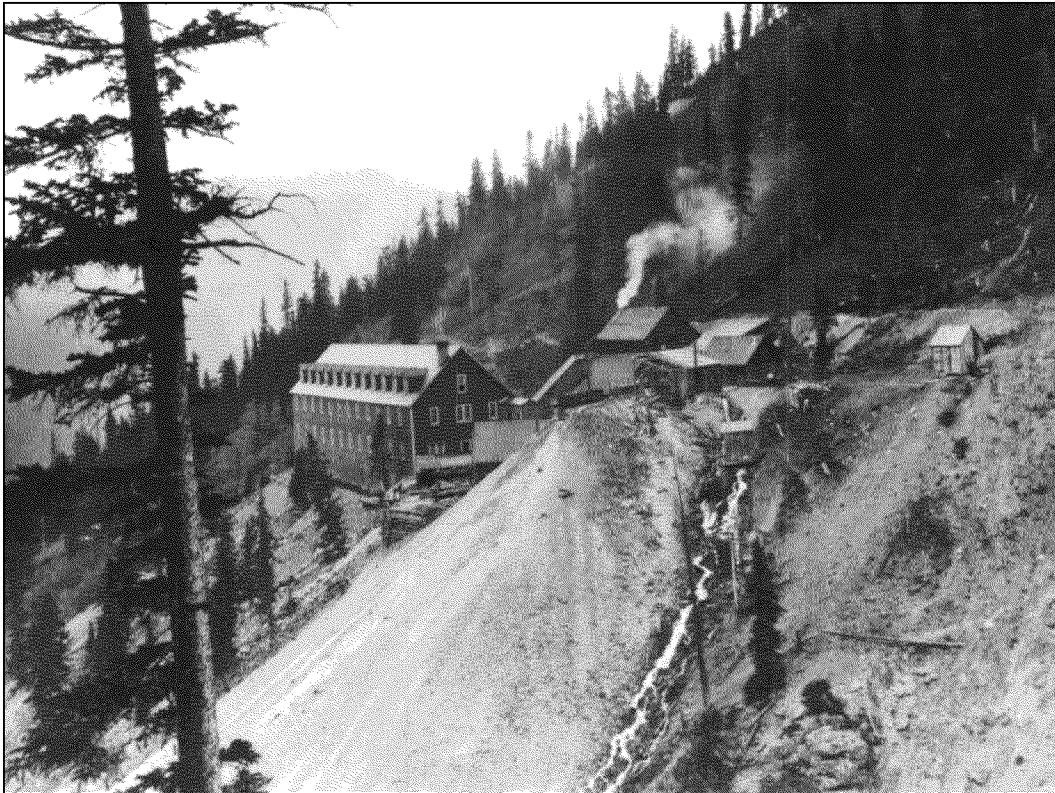
Figure 5.—Historical photograph of the Gold King Mine Level 7 taken prior to the mine closing in 1923. Note the drainage flow down the side of the waste-rock dump.

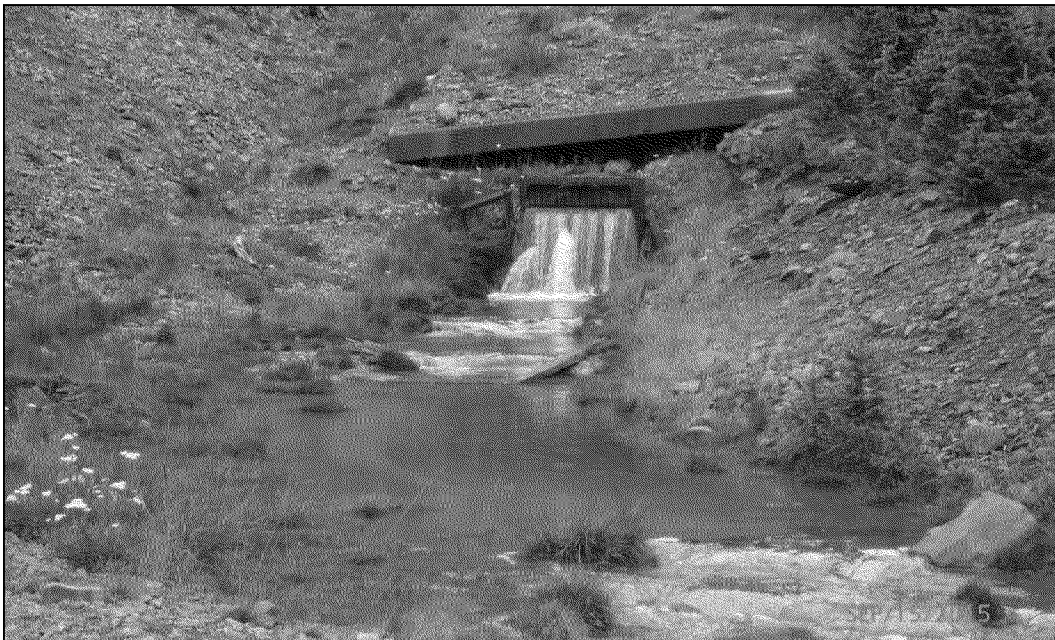
Figure 12.—Photograph taken on September 15, 2015, of drainage from the Silver Ledge Mine, which is located south of the Gold King Mine.

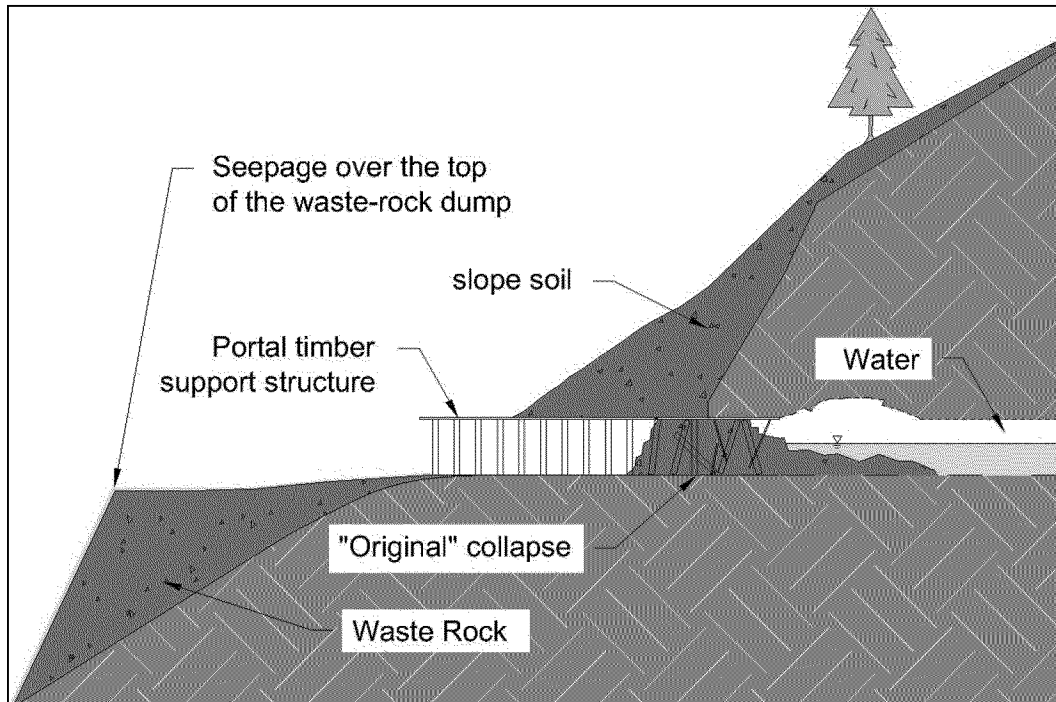
Figure 16.—Cross-section showing the condition of the Gold King Mine Level 7 New Adit in 2007 (not to scale). This shows the water level assumed by DRMS, but it may have been full of water at this time, as was later discovered.

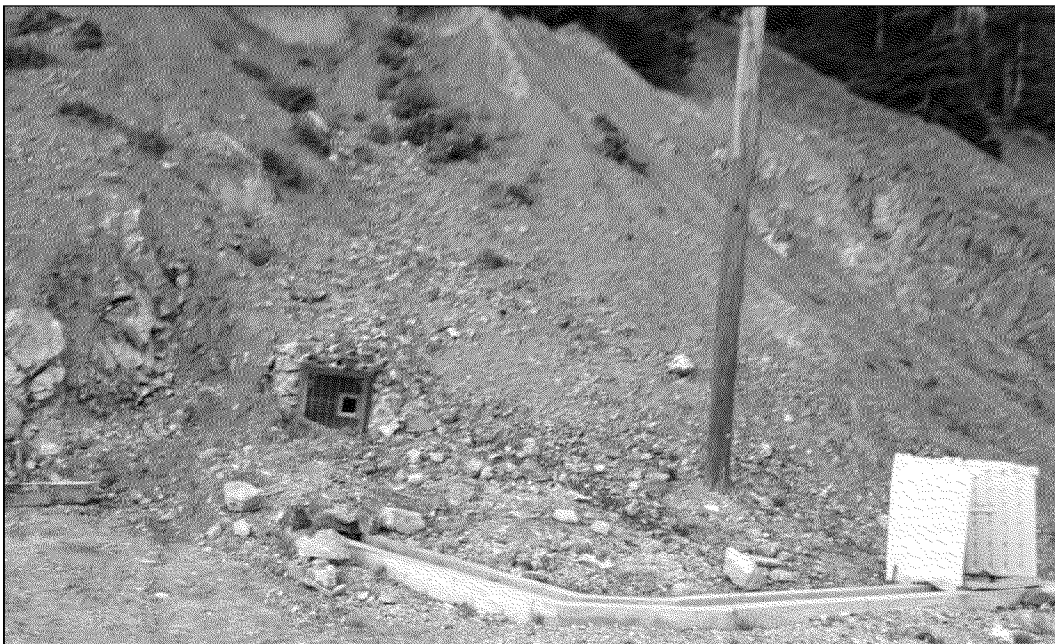
Figure 22.—Photograph showing the condition of the Gold King Level 7 New Adit portal on August 27, 2014, prior to any EPA modifications. Soil and rock debris have migrated downslope and covered a portion of the drain installed in 2009 (photograph from EPA project files).
